BLUE BIRD

R10RW

SUBJECT: RECALL R10RW POWER CABLE LUG ORIENTATION

Incorrect Power Cable Lug Orientation

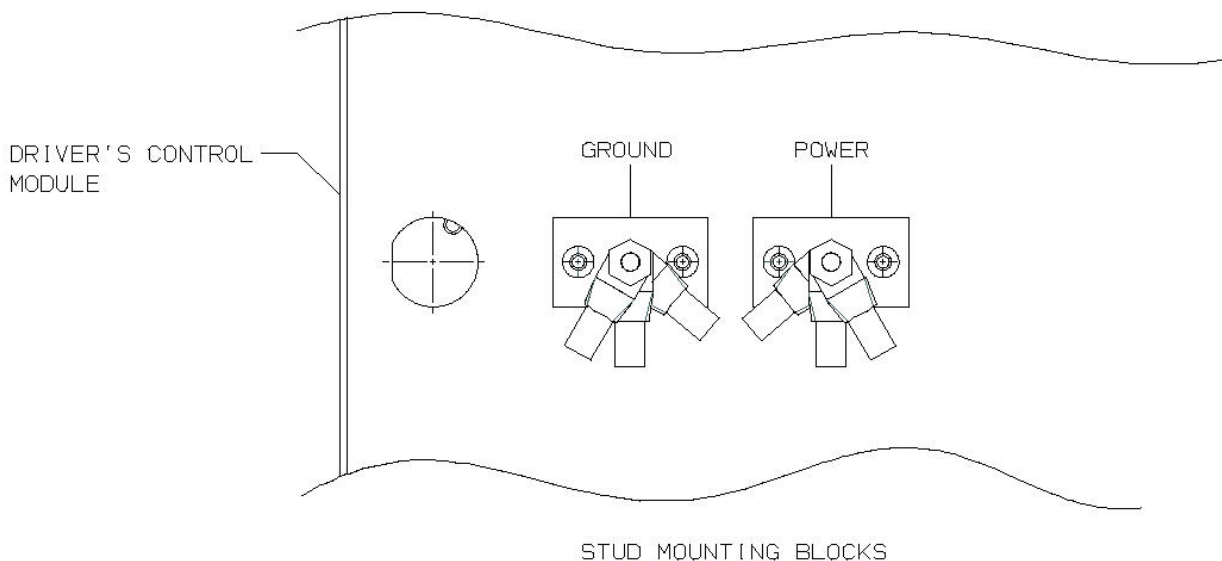
1. Park the vehicle on a level surface, apply parking brake, turn engine off, remove ignition key and chock wheels.
2. Disconnect batteries. *Always remove negative cables first.*
3. Open engine hood and locate the Chassis Power Stud(s) on the driver's side of the **Driver's Control Module (DCM)**. Depending on the type of engine installed and options on the vehicle (air conditioning and/or lift), there could be one or two power studs next to the Ground Stud. See the following diagrams.

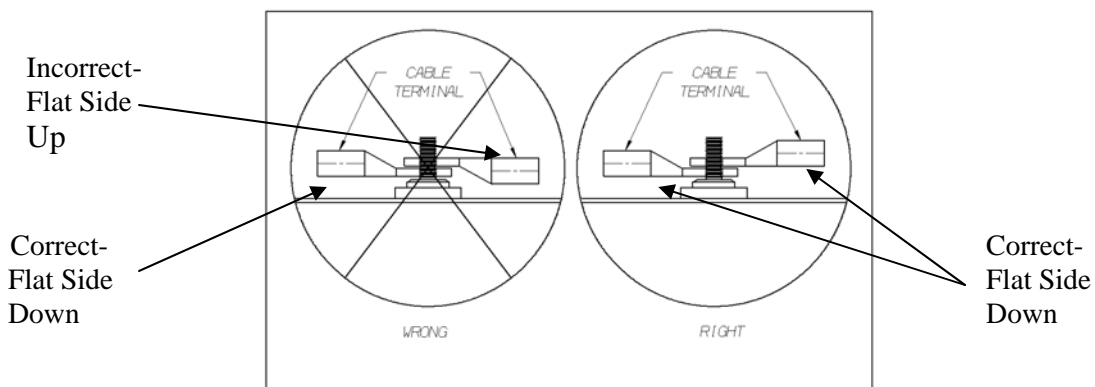
4. Inspect the electrical cable connections at the Power Stud and Aux Power Stud, if installed. See the diagram below to determine if the cables were installed correctly. ALL terminal lugs on each power stud should be oriented such that the barrel of the lug is further away from the mounting surface of the isolated stud. The flat side of terminal end (lug) must be down.

5. If the cables were installed incorrectly, remove the nut securing the cables. Then remove the cables and reinstall correctly per the diagram above. Make sure the terminal lugs are fanned out on the stud as opposed to directly on top of each other. Vice-grip pliers are recommended when turning incorrectly installed cable terminal lug to the correct orientation of flat side down.

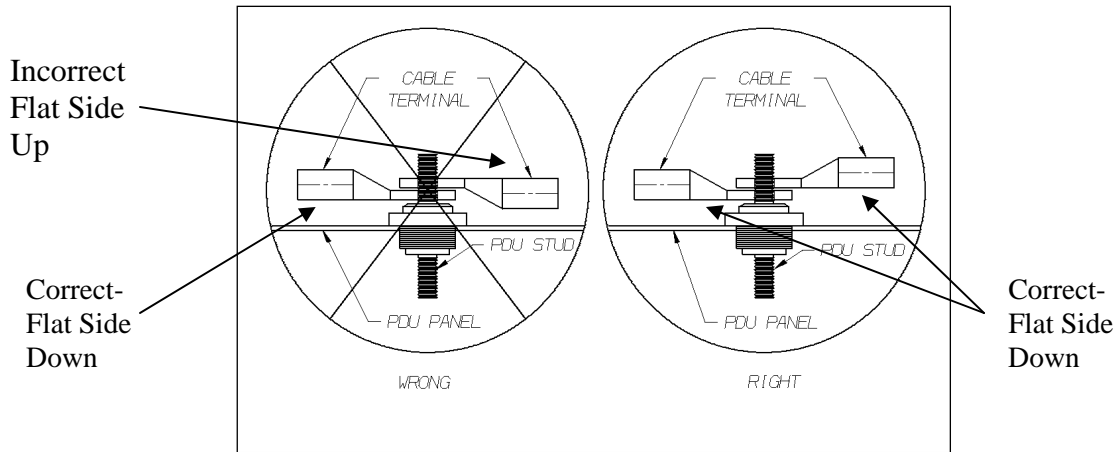
ALL terminal lugs on each power stud should be oriented such that the barrel of the lug is further away from the mounting surface of the isolated stud. The flat side must be down.

11. Remove the nut securing the cables. Then remove the incorrectly installed cables and reinstall correctly with flat side down. Make sure the terminal lugs are fanned out on the stud as oppose to directly on top of each other.
12. If needed, use vise grips to rotate cable so lug fits with flat side down. See photo on page 2.
13. Secure the cables with the nut and torque to 12 to 15 ft-lbs.
14. Apply corrosion resistant coating (glyptal) as required to prevent corrosion.
15. Reinstall the red protective covers.
16. While having access to this area, inspect ALL power cables for any evidence of contact with the rear of the engine, chaffing, or other damage. **Ensure clearance between power cables and any part of the engine is more than ½ inch.**
