BLUE BIRD

R10RW

SUBJECT: RECALL R10RW POWER CABLE LUG ORIENTATION

Incorrect Power Cable Lug Orientation

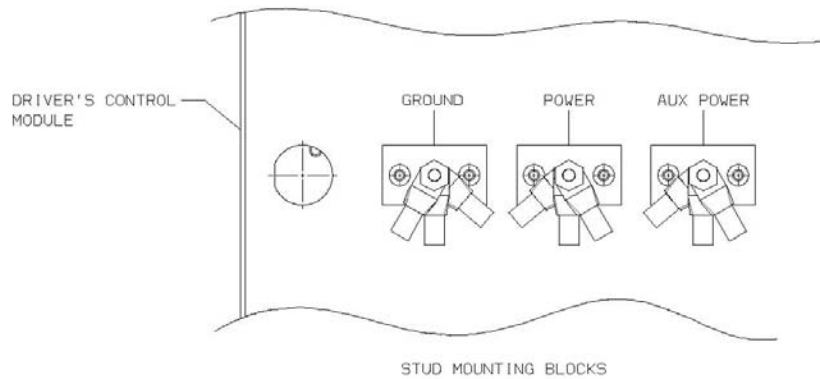
1. Park the vehicle on a level surface, apply parking brake, turn engine off, remove ignition key and chock wheels.
2. Disconnect batteries. *Always remove negative cables first.*
3. Open engine hood and locate the Chassis Power Stud(s) on the driver's side of the **Driver's Control Module (DCM)**. Depending on the type of engine installed and options on the vehicle (air conditioning and/or lift), there could be one or two power studs next to the Ground Stud. See the following diagrams.

4. Inspect the electrical cable connections at the Power Stud and Aux Power Stud, if installed. See the diagram below to determine if the cables were installed correctly. ALL terminal lugs on each power stud should be oriented such that the barrel of the lug is further away from the mounting surface of the isolated stud. The flat side of terminal end (lug) must be down.

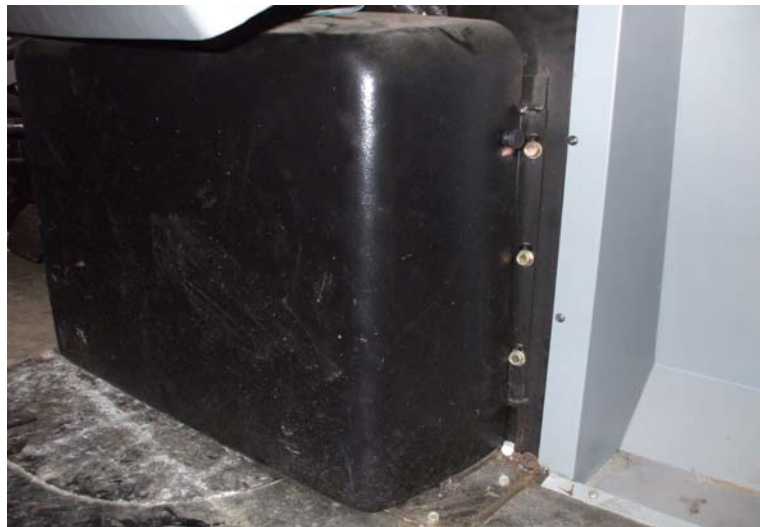
8. Next, the Chassis Power Studs located behind the PDU must be checked. To gain access behind the PDU go inside the vehicle and do the following:
 - a. Remove the Power Distribution Unit (PDU) cover by unscrewing the two thumb screws, located at the top of each side of the cover.

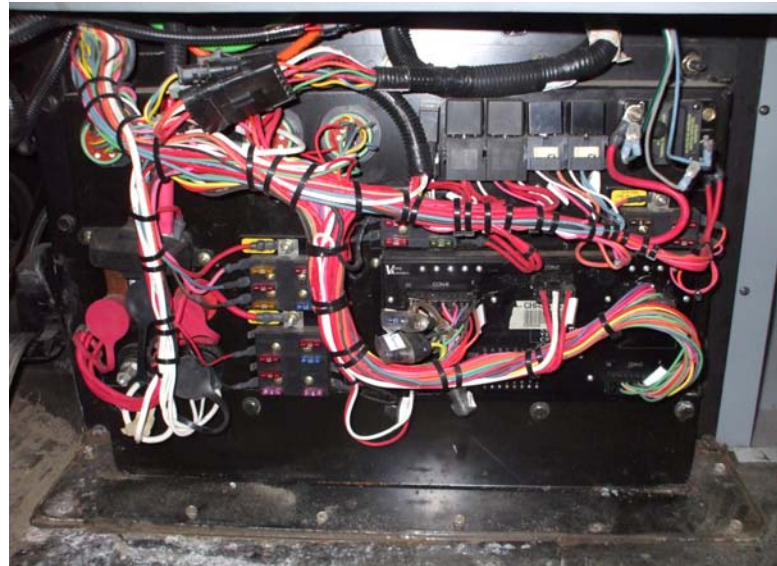
- b. Remove the fasteners securing the PDU to the Driver's Control Module (DCM) and the fasteners securing the PDU to the floor.

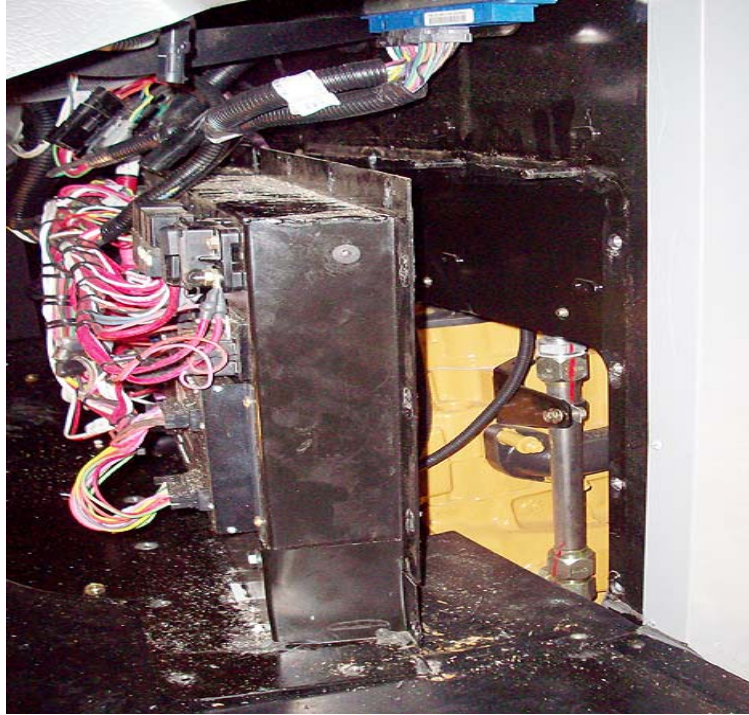
- c. Carefully slide the right side of the PDU rearward far enough to access the wiring behind the engine.

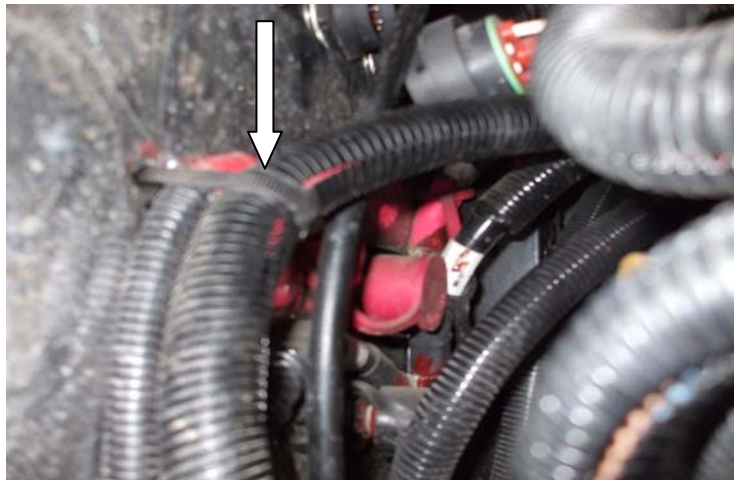
- i. To gain access behind the PDU to inspect and possibly correct the cables, it may be necessary to cut the two cable ties securing cables to the PDU.

The upper cable tie is shown below.

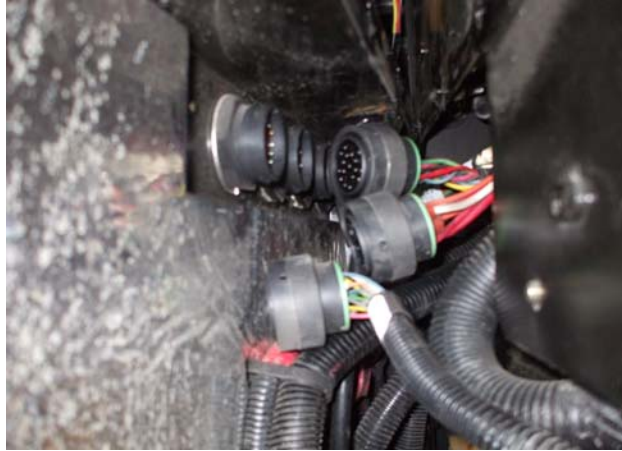
- ii. To gain better access it may be necessary to disconnect the 4 Deutsch connectors.
